The evolution and application of 3D limit equilibrium modelling to assessing open cut coal mine slope stability

ABSTRACT: Over the last five years the application of 3D modelling to assess slope stability has increased significantly as 3D modelling software becomes more widely commercially available and user friendly. 3D modelling is particularly beneficial if: (i) the failure mechanism is driven by the interaction of structure as well as breaking down of rock bridges (implying the rock mass under investigation is anisotropic); and (ii) the slope analysed includes confining or variable geometries that will not be accurately represented in a 2D model. When modelling in 3D generic material parameters, or those derived from the back analysis of 2D cases, should not be directly applied to 3D models. This is because the failure mechanism being modelled in 2D does not generally represent the actual failure mechanism observed in the pit, with 2D modelling often oversimplifying a slope. This paper outlines four case studies where slope geometry is complex and 3D limit equilibrium modelling has been used to back analyse material strengths in open pit coal mines. 3D back analysed strengths

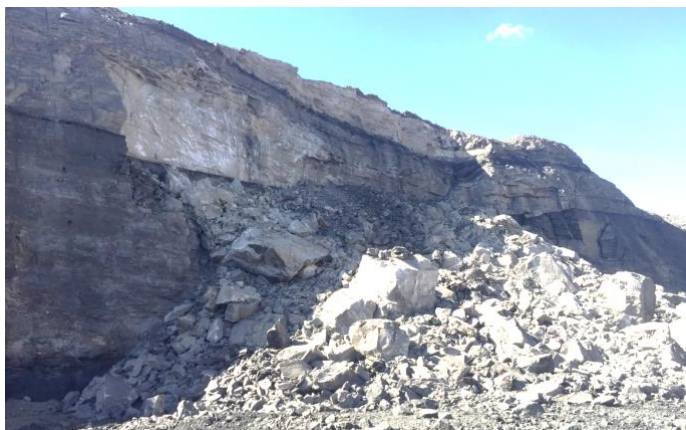
Figure 1 Case study 1, post failure slope conditions

Case study 1, Figure 1, was excavated using a dragline for the main overburden and then truck and shovel for coal removal. The slope was pre-split to a design of 65° and consisted of a sandstone upper band approximately 10 to 15 m thick, followed by an interbedded sandstone and siltstone horizon down to the target coal seam. Failure occurred through intersecting joints, bounded at the base of the failure by a coal seam. Elevated water pressures behind the pit crest were present at the time of failure. Back analysis was completed to determine appropriate material strengths for 3D LE modelling. Initial assessment of slope stability had been completed using 2D LE analysis and had indicated a FOS of > 1.2 . This slope geometry was the first case study the authors had back analysed in Slide3 software in 2017. For the first iteration of 3D modelling generic Bowen Basin material strengths were input into the model. Material strengths assigned for fresh coal measure rock (cohesion = 450 kPa; friction angle = 42°) were isotropic and did not explicitly account for persistent joints. The calculated FOS was 2.5, Figure 2.

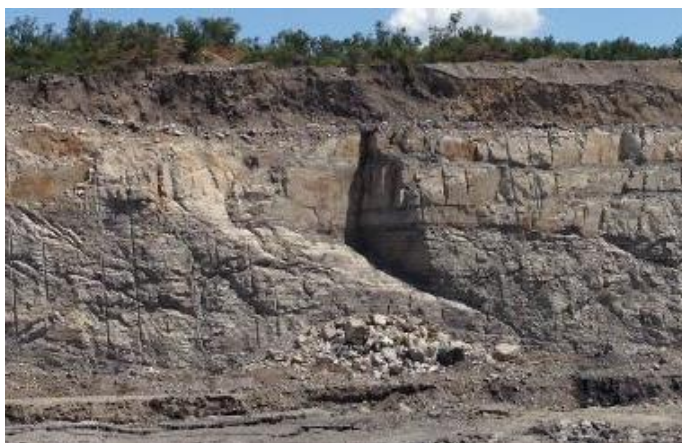
Figure 5 Case study 2, post-failure slope conditions

Case study 2 was sourced from an operational open cut coal mine in Queensland. Case study 2 was excavated using a dragline for the main overburden and then truck and shovel for coal removal. The excavated slope under review was pre-split to a design of 75° and consisted of a sandstone upper unit approximately 10 m thick, followed by an interbedded sandstone and siltstone horizon down to the target coal seam. Failure occurred through three intersecting persistent joints (two sub-vertical and one oblique joint set) daylighting in the excavated face, Figure 5.

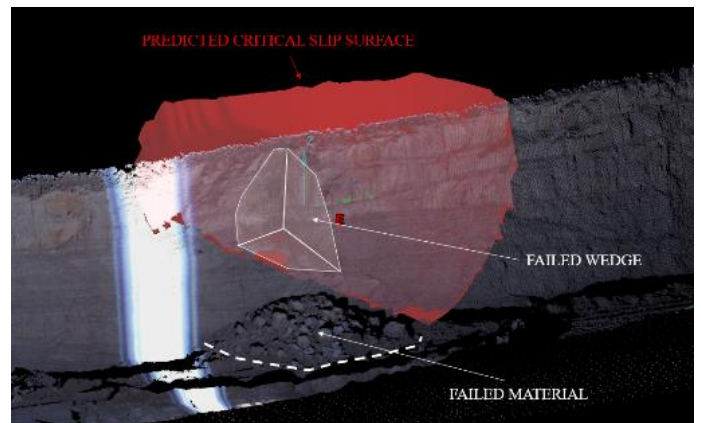
Figure 6 Perspective view showing Slide3 predicted critical failure surface (red polygon) and actual failure dimensions

Slide3 model results are presented in Figure 6. A critical FOS of 0.49 was calculated.

Comparing the location of the critical failure surface calculated for pre-failure slope conditions with Slide3 results, there is good correlation between the Slide3 predicted critical slip surface and where failure actually occurred, Figure 6. A minor discrepancy can be observed in the size of the failure predicted, with Slide3 predicting a larger failure than actually occurred, Figure 6. This is attributed to no failure size restrictions being placed on the search command. A FOS appreciably lower than 1, i.e. 0.49, was accepted where slope failure was kinematically likely given the intersection and daylighting of three persistent defects. Under such conditions a FOS appreciably lower than 1.0 could be expected.

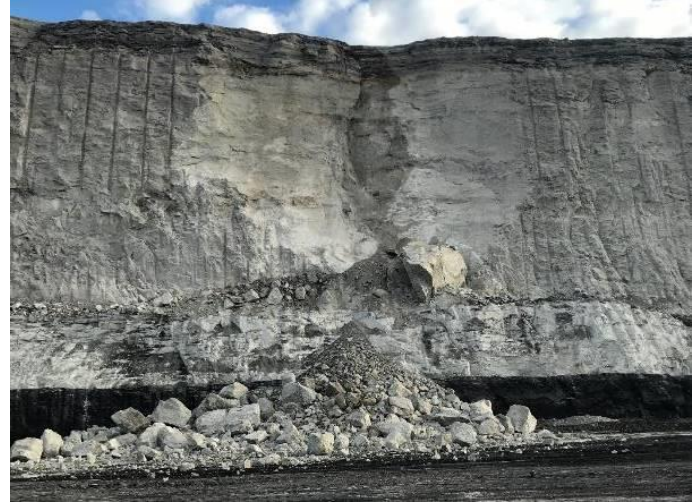
Figure 8 Case study 3, post failure slope conditions

Case study 3 is a 30 m high excavated slope pre-split to a design of 75°. The case study is sourced from an open cut mine in New South Wales, where the slope consisted of predominantly sandstone down to the target coal seam. A prominent fault intersected the slope at an acute angle (within approximately 20° of the slope orientation) and dipped in the same

direction as the slope orientation. Failure occurred at the intersection of the fault and batter scale persistent joints, Figure 8. Elevated water pressures behind the pit crest were present at the time of failure due to surface water seepage from a recent rainfall event.

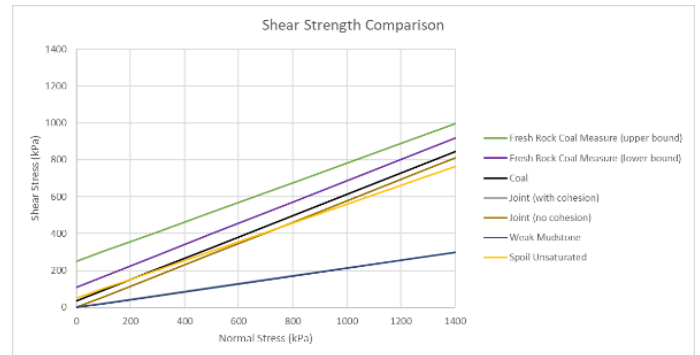
Figure 13 Shear strengths applied to 3D LE modelling for coal measure rocks

Material strengths applied to successfully back analyse the stability of open pit slope cases are summarised in Figure 13. The geotechnical environment these material strengths have been derived in typically fall within a GSI range of 45 to 55 for fresh coal measure rock (10 to 20% lower for jointed coal measure rock), which equates to an approximate RMR range of 40 to 50.
